- On PS Ring
- About 200 flanges to be measured,
- Use of a trolley with big pneumatic wheels because of the rails on the PS
- **1st part of the job:** Interventions where Vacuum chambers are disconnected, we previously removed all the RF Bypasses according to a given list then once the Vacuum group has finished each one of them, we measure the impedance of the flange as the collars risk to damage the enamel insulation of the flanges and cause short-circuits. If ok, we put back the RF Bypass and make a measurement to be sure. 200uS radiation taken.

RF Bypass Impedance Measurements

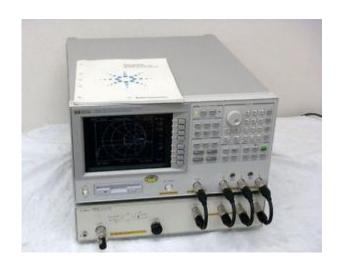
SS02 Upstream

... 2013, then 2015 and 2016 Agilent 4395A

843.08 m Ω -354.23 m Ω 447.72 nF

1.003536177 MHz

- Fast Boot 15s
- 30s state load from FDD
- Image saved to FDD, about 1 minute

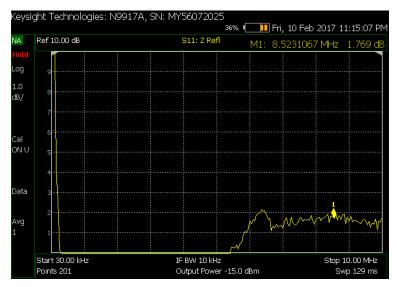
SS46V

- One of PC Laptop,
- © Friendly user interface software,
- © Very Fast Scanning,
- © Easy to save plots, (need keyboard)
- © Start Frequency at 30kHz,
- ⊗ Only Linear Frequency Scale ⊗

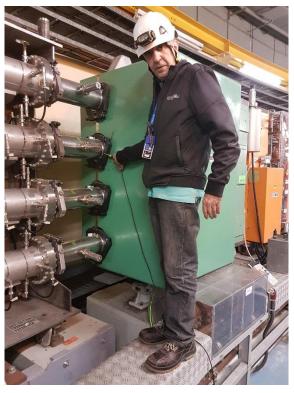
Copper Mountain Technologies TR5048

- Used with a laptop,
- Needs 1.25A, 12V, power supply,
- Very fast scanning,
- We used this trolley with only the UPS powering,
- All 120 measurements in about 1hour,
- Radiation taken: Joao 8uS, Bruno 4uS.

- All 120 measurements in about 1 hour without saving plots,
- The UPS can handle it, over 50% left,
- Radiation taken: Joao 8uS, Bruno 4uS,
- Measurement from interior or exterior of the ring could improve speed of measurements,
- The biggest part of time can be saved if cord extension is avoided,
- Continue to search a better portable USB connected VNA solution, automatization of the measurements.
